The Effect of Surface Treatment on The Degradation of Composite Adhesives

Prashanti Pothakamuri

Lloyd Smith

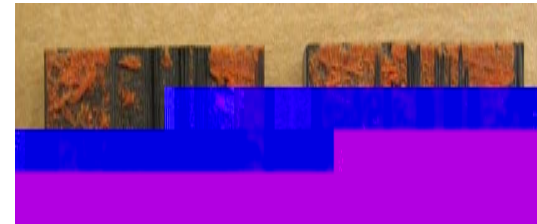
- TWSL failure modes

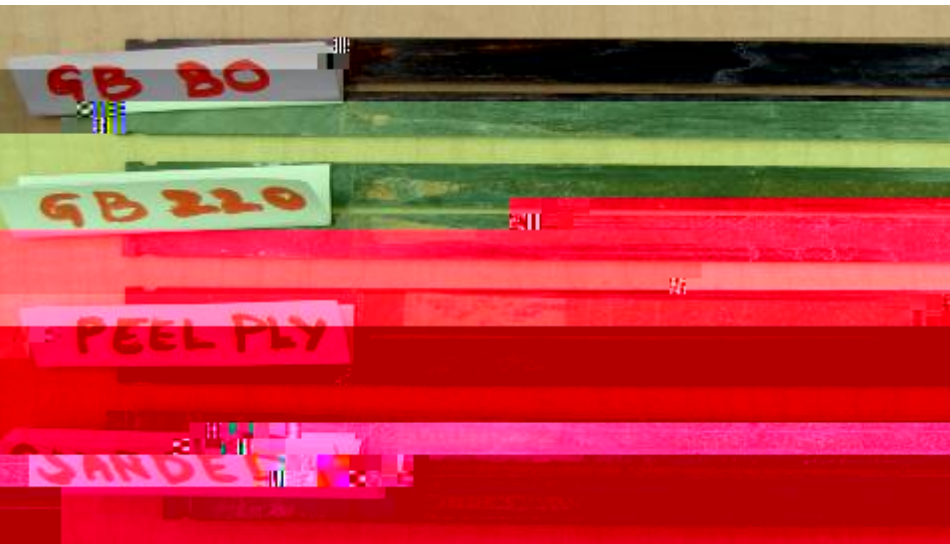
- Failure modes similar to baseline results

- GB 80 - 100% adherend
- GB 220 - 60% cohesive
40% adherend
- Peel ply - 50% adherend
50% cohesive
- Sanded – 20% adherend
80% cohesive
